# Manhole Inspection Summary

Manhole # S21G\_\_034MH

**Location** Address: **1726 BRUCE ST** Cross Street: **BALTIMORE ST**

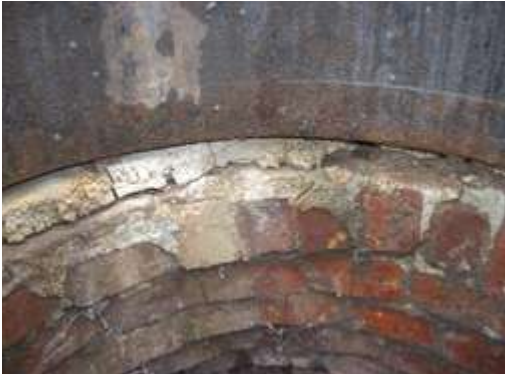
Defect 3

**Chimney / Frame Adjustment** ☒ Exists Material: **Brick and Concrete** ☐ Parged Height: **4** (in.)  
Condition: ☐ Sound ☐ Cracked ☐ Root Intrusion ☐ Loose Brick ☒ **Deteriorated**  
Infiltration: ☒ None ☐ Joint ☐ Cracks ☐ Mortar ☐ Roots ☐ Wall

DETERIORATED CHIMNEY

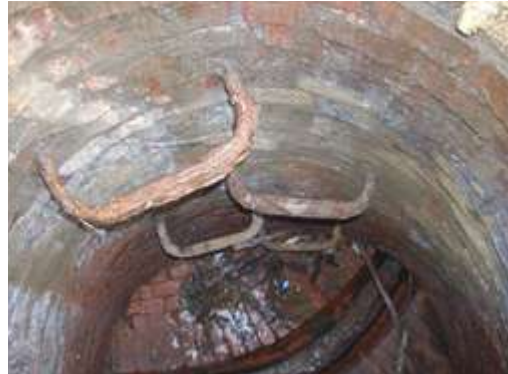
Defect 2

**Steps** Count: **4** Missing: **0** ☒ **Corroded**

CORRODED STEPS

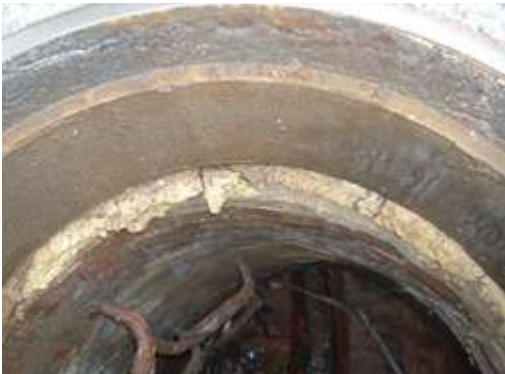
Defect 1

**Frame** Offset: **1** (in.) Condition: ☒ Sound ☐ Cracked ☐ Leaks

FRAME OFFSET

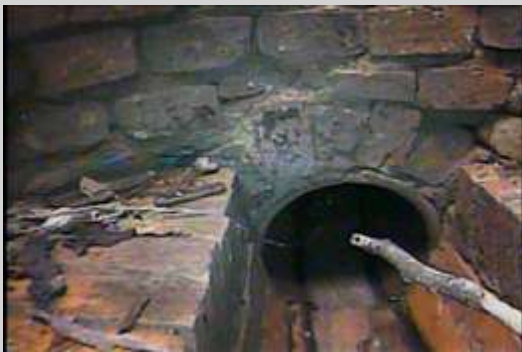
12 O'Clock Outflow

8 in. Circular Gravity Sewer  
Pipe Out @ 12 O'Clock

Pipe Height: **7.2** (in.) Rod and Bar (Angled)  
Pipe Material: **Clay** ☐ Pipe Lined  
Invert Depth: **7.52** (ft.) Flow Characteristics: **Fast**  
Deposits: ☒ None ☐ Mud ☐ Sludge ☐ Debris ☐ Grease  
Silt Depth: (in.) Deposits Extent:  
Infiltration: **None** Pipe Seal Cond: **Sound**

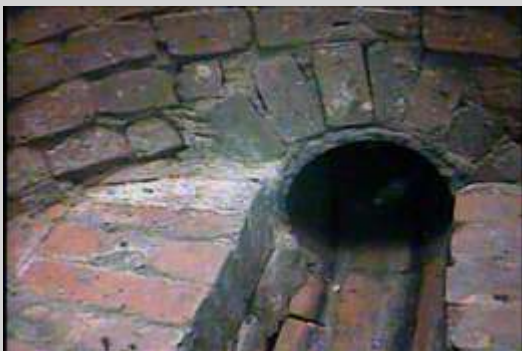
8 O'Clock Inflow

8 in. Circular Gravity Sewer  
Pipe In @ 8 O'Clock

Pipe Height: **8.4** (in.) Rod and Bar (Angled)  
Pipe Material: **Clay** ☐ Pipe Lined  
Invert Depth: **7.17** (ft.) Flow Characteristics: **Fast**  
Deposits: ☒ None ☐ Mud ☐ Sludge ☐ Debris ☐ Grease  
Silt Depth: (in.) Deposits Extent:  
Infiltration: **None** Pipe Seal Cond: **Sound**
